Notification

Update of Airspeed Indicator and POH

Release Number: NOT-014-ASI update

Models affected: GX, certified as LSA

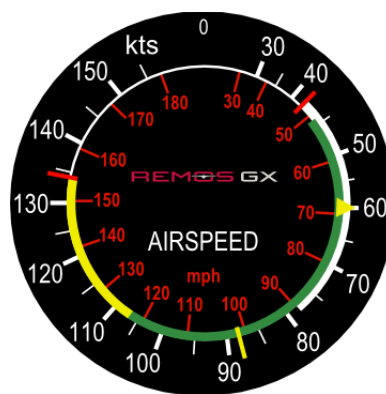
The markings on the airspeed indicator must comply with section 2 of the pilot operating handbook. Markings in knots indicated (KIAS) are mandatory, markings in mph indicated are optional.

marking	IAS
Red Line, low	42 kts 48 mph
White Arc	42...78 kts 48...90 mph
Yellow Line	88 kts 101 mph
Green Arc	44...107 kts 51...123 mph
Yellow Arc	107...134 kts 123...155 mph
Red Line, high	134 kts 155 mph
Yellow Triangle	60 kts 69 mph

- placing new markings with a permanent marker (not recommended)
- placing marking stripes on the glass of the airspeed indicator
- install a new airspeed indicator acc. to maintenance manual
