SAFETY ALERT

Fixing of Strut Bearings

Release date: 24. June 2008

Issue number: SA 003-strut-bearings

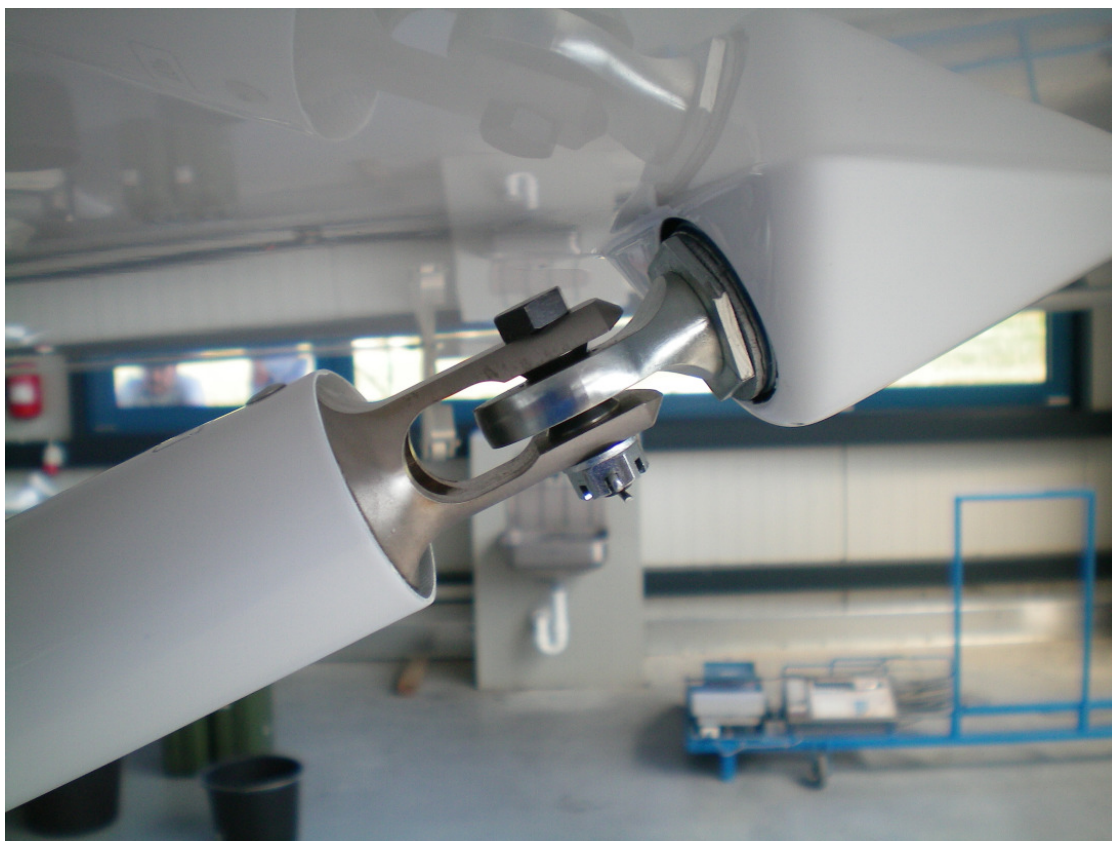
The wing struts are attached to the wing and to the fuselage by means of a ball bearing on each side. The ball bearings are attached into its attachment with tight fit only. Correctly installed, the strut attachment to the wing looks like shown in figure 1.

figure 1 - correct installation of upper strut attachment

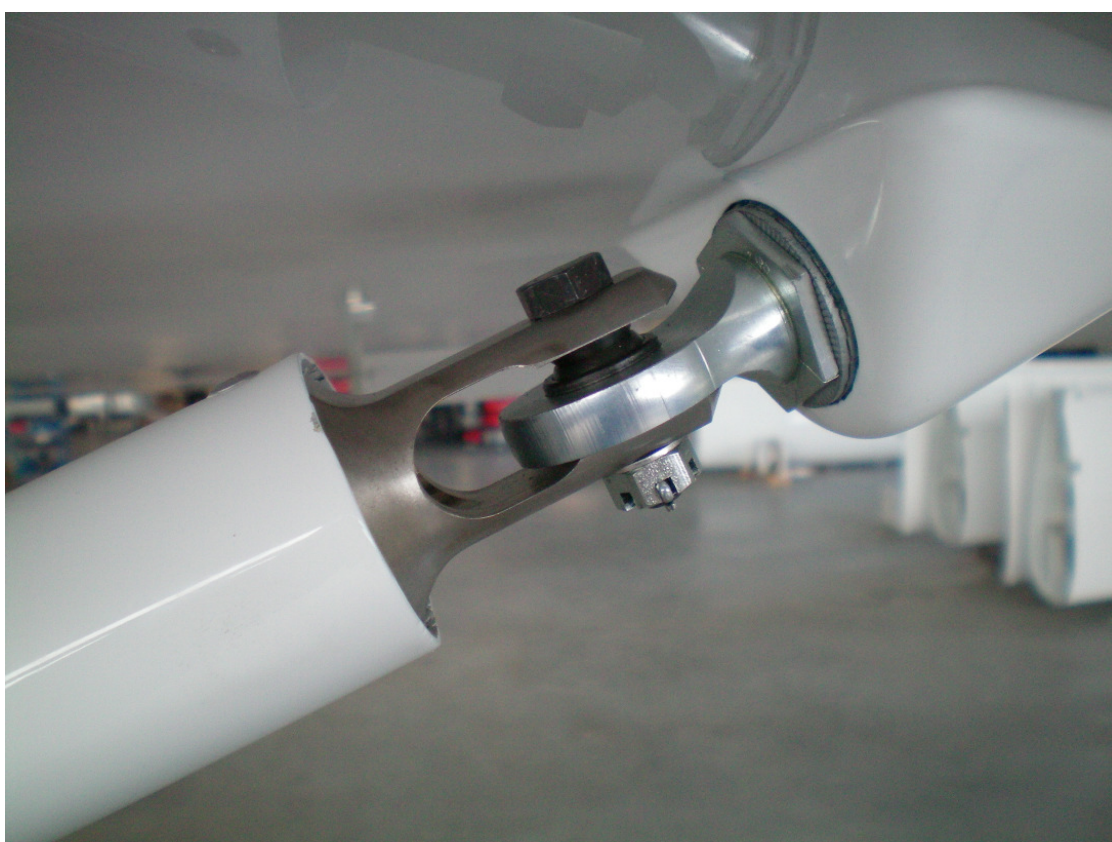
On some aircraft in final assembly line it has been found, that the manufacturing tolerance of the attachment was too big, the ball bearing can get loose, see figure 2 for explanation.

figure 2 - wrong installation of upper strut attachment with loose ball bearing

Service Directive SD-003 describes how this problem is fixed.
