## Notification

### Grounding Modification

Release Number: NOT-002-grounding

Models affected: G-3, G-3/600, GX

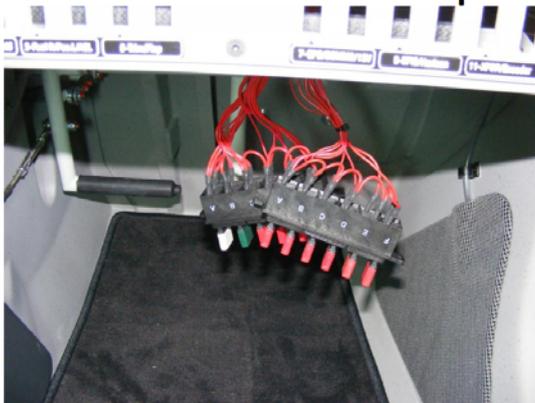
### Fuse panels

On some aircrafts there has been a problem with the electrical system. The electrical power supply was not sufficient, resulting in failure of navigation and communication equipment. This resulted in complete discharge of the battery causing the battery and therefore the electrical system to fail.

Remove fuse panels as shown and cut back heat shrink on spade terminals to allow soldering.
