Service Directive

Inspection of pipes and hoses of the coolant system

Release Number: SD-003-coolant system

Models affected: G-3, G-3/600

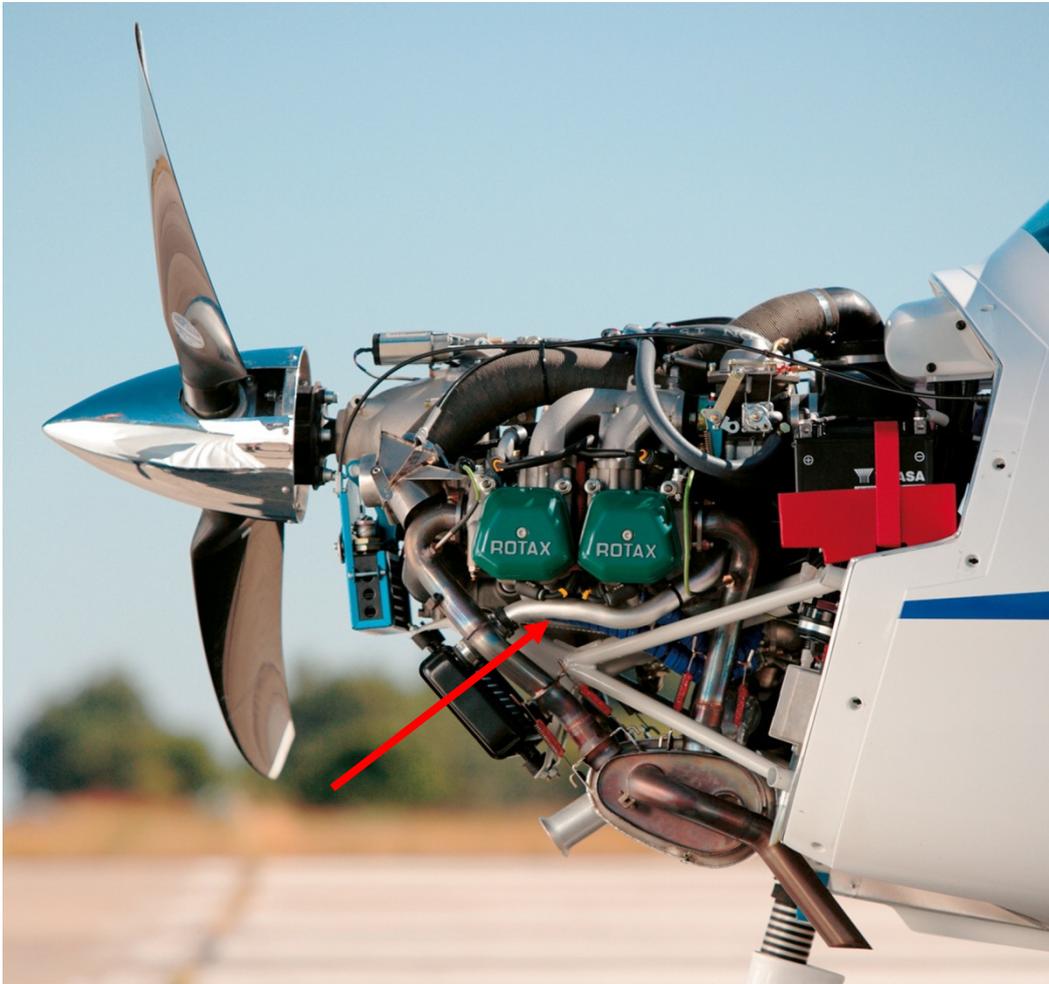
Reason: The coolant tube of a REMOS G3/600 was routed too close to the valve pushrod tube of the front-left cylinder. The coolant pipe is made of aluminum, and was

rubbed through by the valve pushrod tube. A loss of coolant was the result (see figure 1 to 3).

Figure 1 – Lying of the cooling water tube

1. Open up the upper cowling.
2. Completely disconnect the battery and secure positive pole against unintended contact.
3. Open up the lower cowling.
4. Identify the coolant hoses, especially the coolant water tube (see figure 1). See the ROTAX Repair- and Maintenance Manual for more Information. Use the latest revision. Available under: www.franz-aircraft.de
5. Inspection of all hoses and pipes of the coolant system. Check for damages and correct distance to ***all parts of the aircraft engine, engine units, and incl. exhaust system.***
6. Check and judge the condition of all pipes and tubes of the coolant system.

■ CAUTION: The distance between coolant pipes/coolant hoses and all parts of the aircraft engine needs to be at least 10 mm.

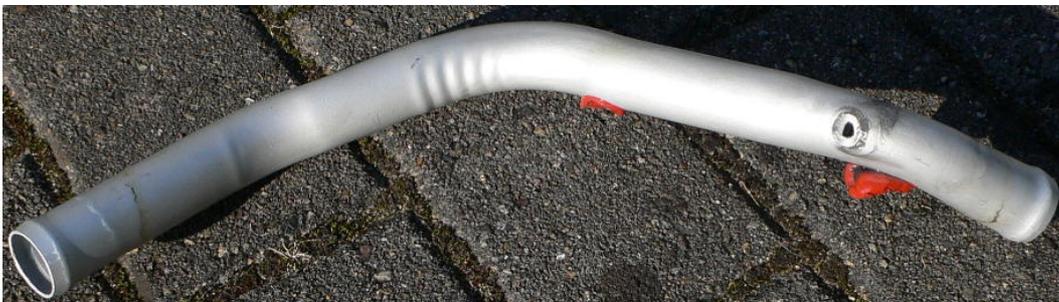
Figure 2 – Damaged cooling water tube

7. Exchange the coolant pipes/coolant hoses if necessary. Only use original spare parts by ROTAX or REMOS.
8. Fix the coolant pipes/coolant hoses with wire strap. Cut off the ends of the tightened wire straps.
9. Remove and replace the pipes and hoses if you cannot ensure the correct laying of the coolant pipes/coolant hoses. You have to fix the hoses and pipes afterwards.

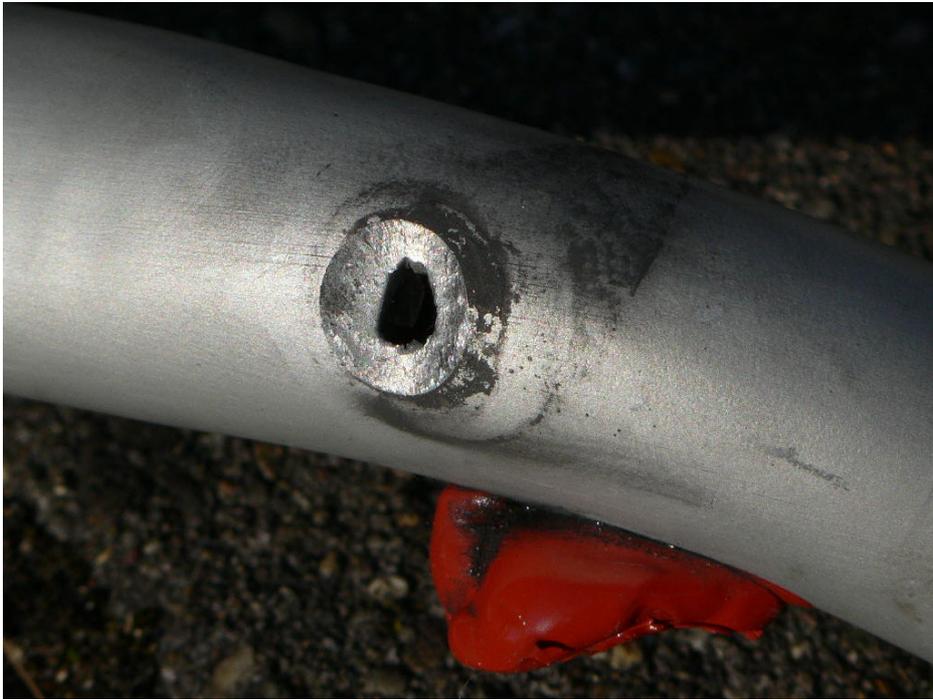
Figure 3 – Detail of defect cooling water tube

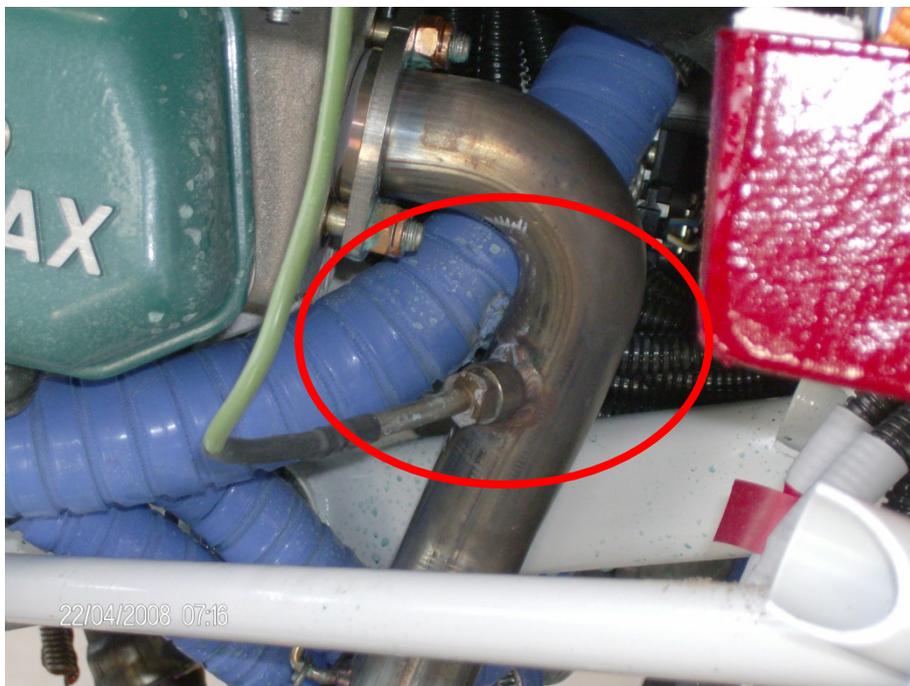
On another aircraft the coolant hose was routed too close to the exhaust system, so it was damaged (see Figure 4).

Figure 4 – Defect coolant hose

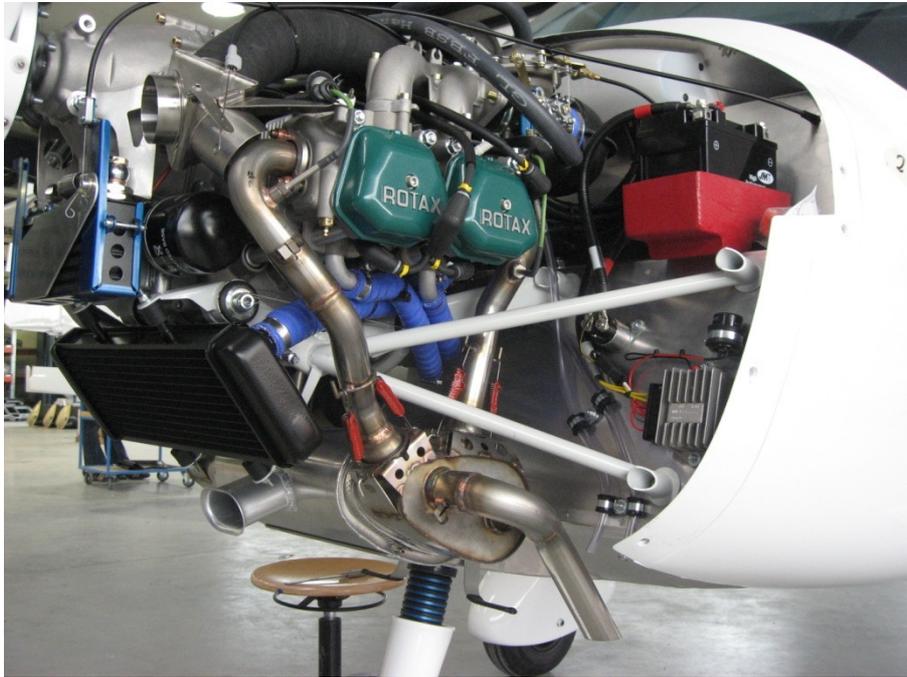
Figure 5 – Overview correct hoses from/to the engine, left-hand side

◆ NOTE: The accurate laying of the coolant pipes can be seen in figure 5 to 10.

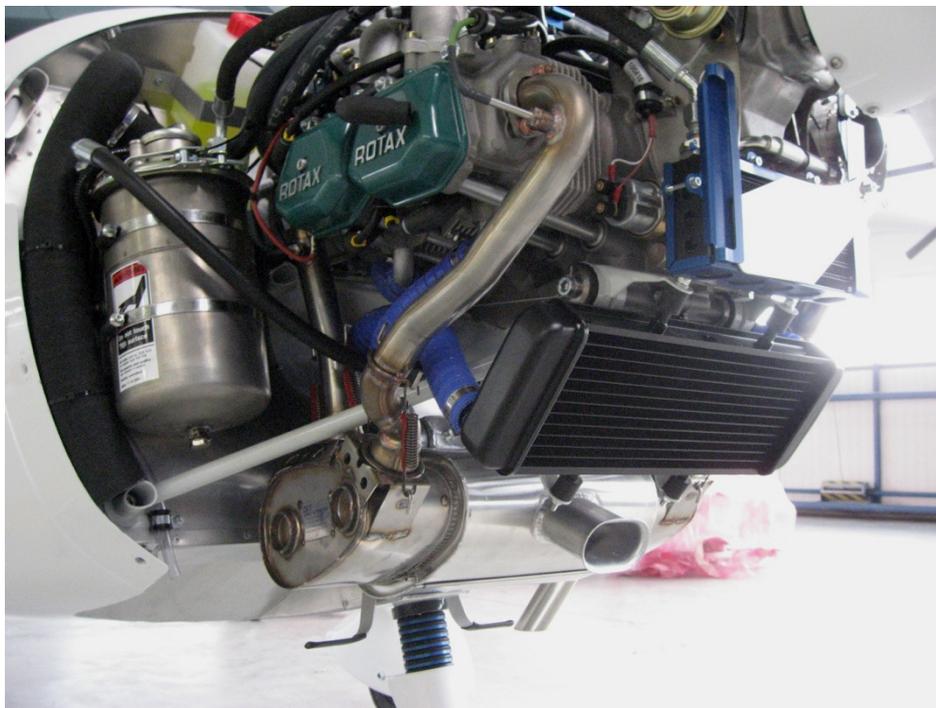
Figure 6 – Overview correct hoses from/to engine, right-hand side

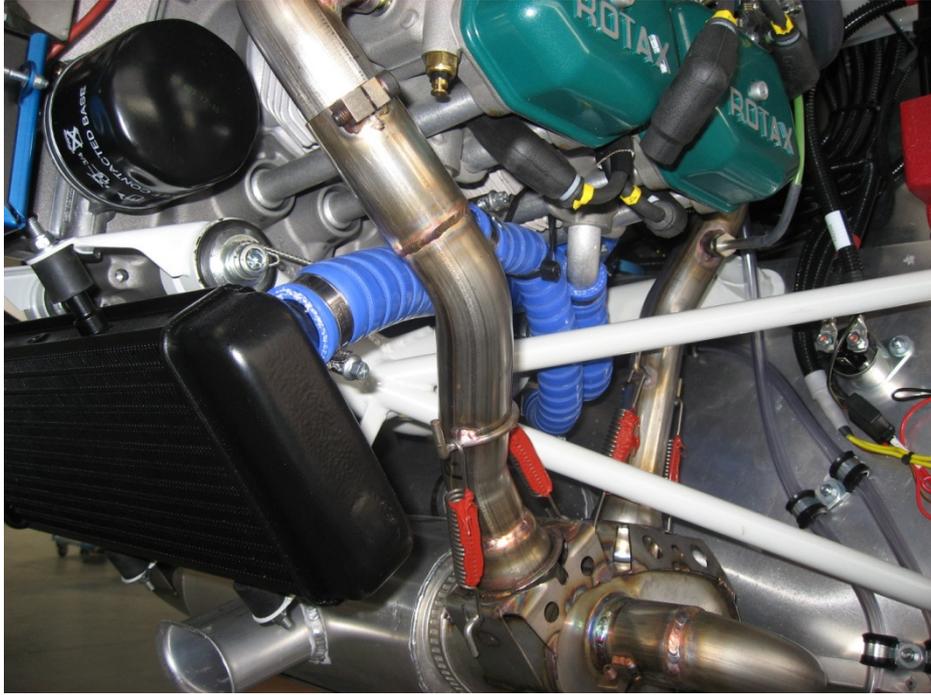
Figure 7 – Hoses from/to engine, detail view left-hand side

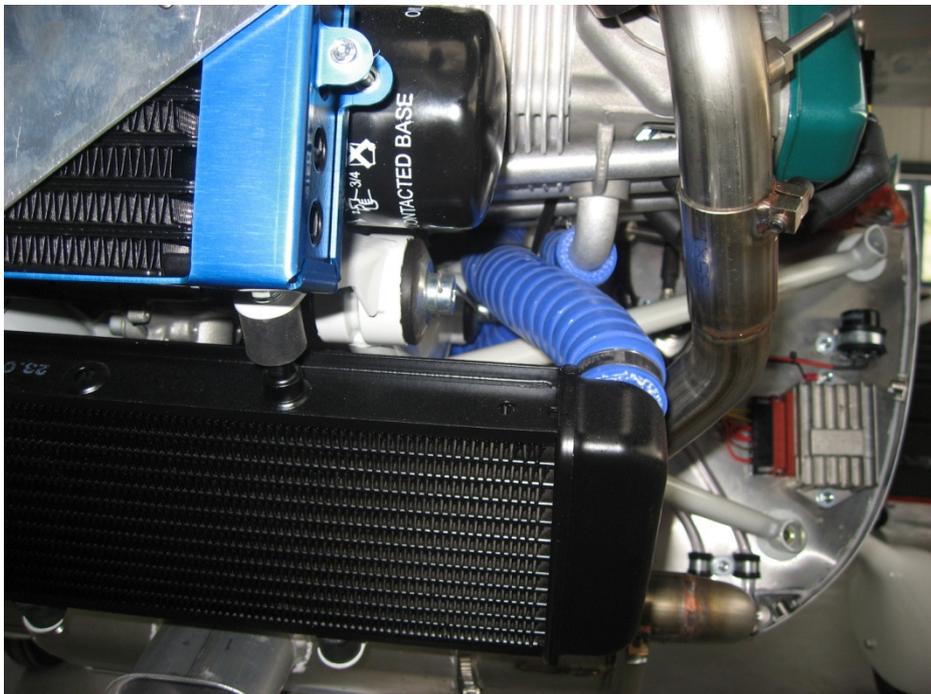
Figure 8 – Hoses from/to engine, detail view front-left

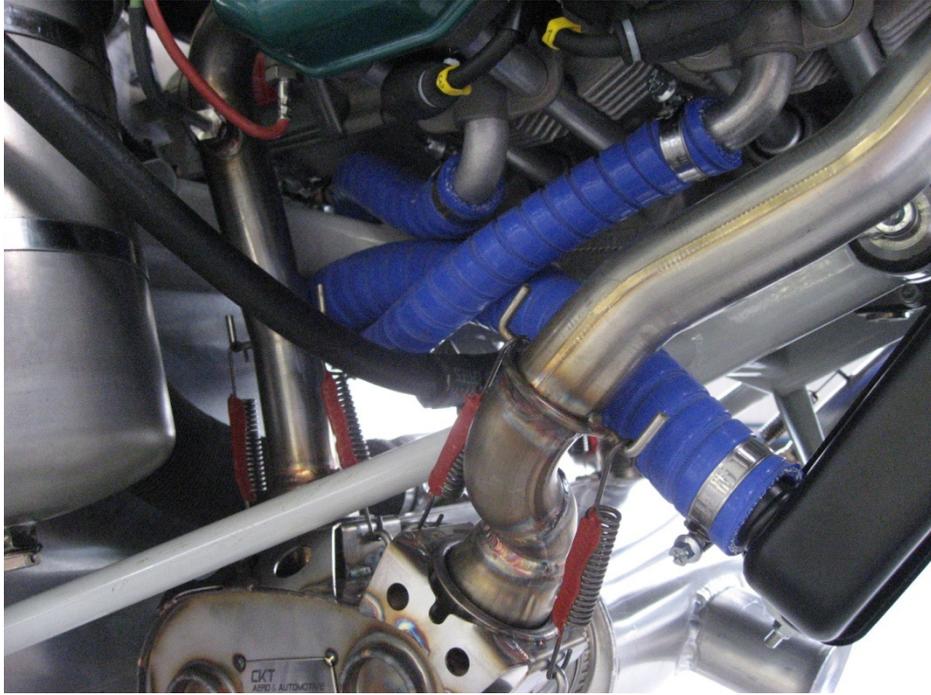
Figure 9 – Hoses from/to engine, detail view right-hand side

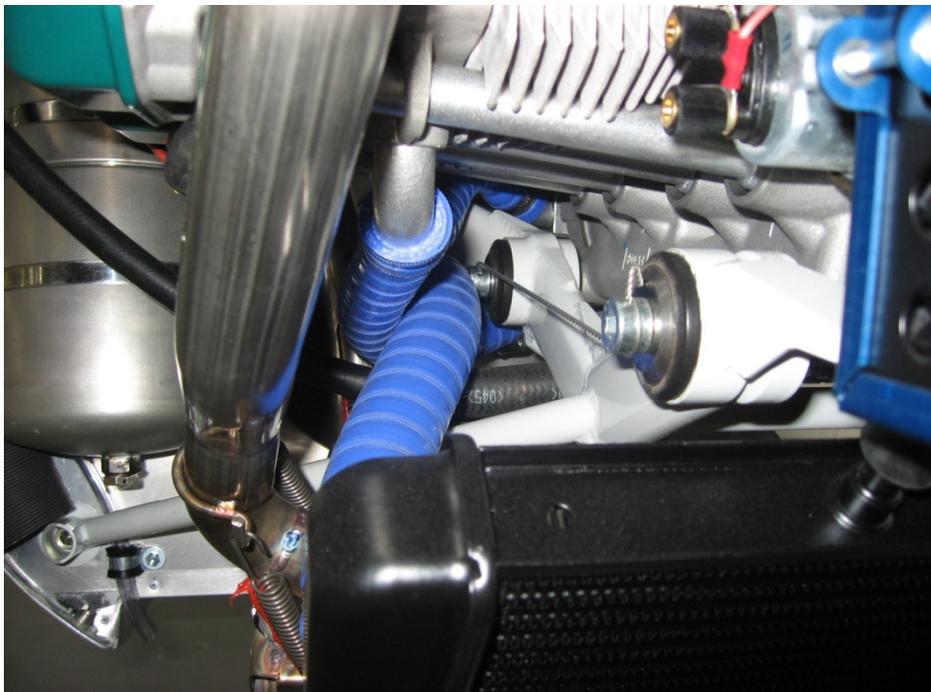
Figure 10 – Hoses from/to engine, detail view front-right
