# SAFETY DIRECTIVE

## Check of throttle control guides Model G-3/600

Issue number: SD G3-1-2005

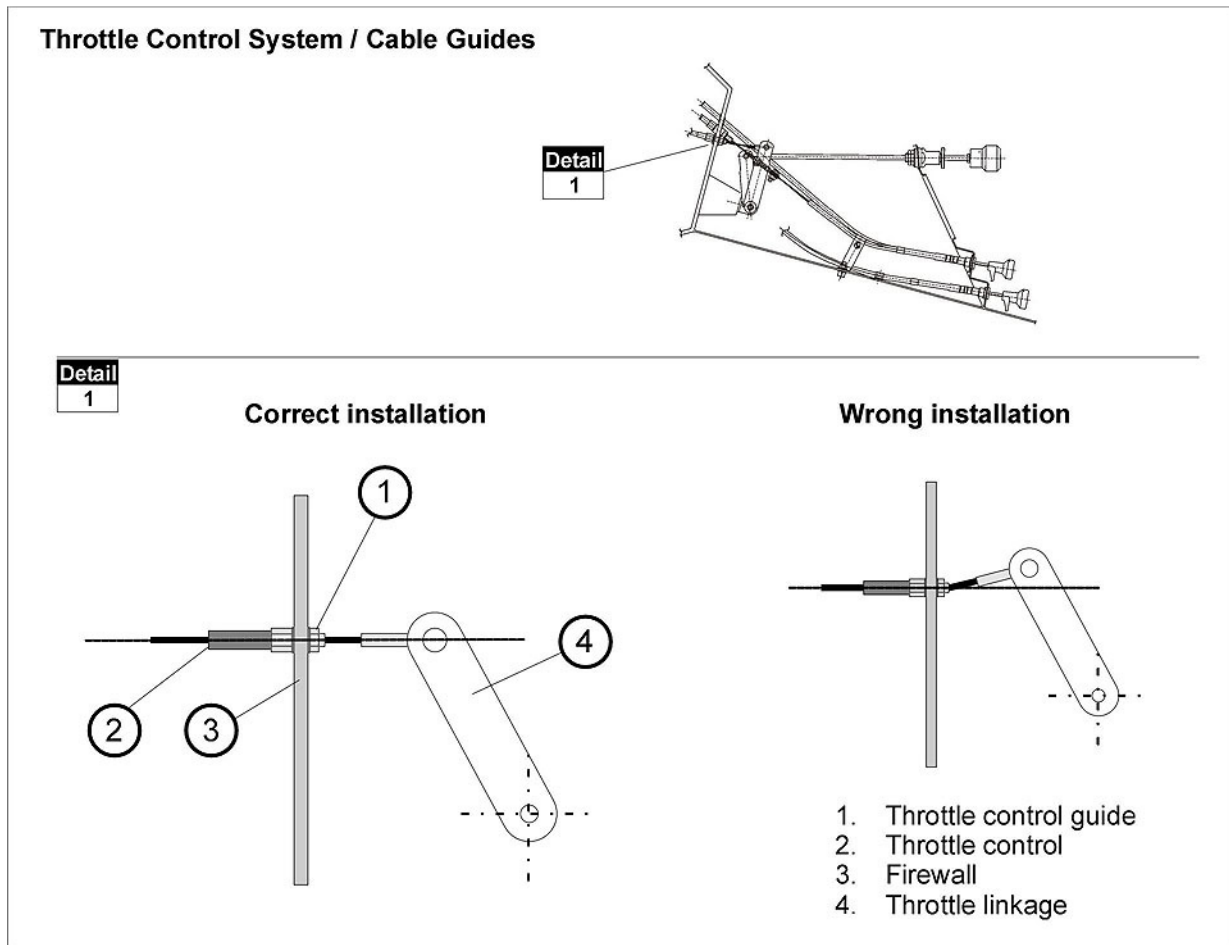
Figure 1-1

Reason: Uncorrect fitment of throttle control cable guides

Instructions: Check location of throttle control guide as illustrated in figure 1-1 and restore to original operating configuration.

Test / Inspect: Conduct test run and rigging of throttle controls in accordance with current Maintenance Manual of the G-3/600.
