## Safety Alert

### Inspection of Elevator Pushrods and Their Bearings

| <u>Release number:</u> | SA-009-elevator pushrods |

| <u>Subject:</u> | Inspection of elevator pushrods and their bearings and application of a protective liner on the pushrods. |

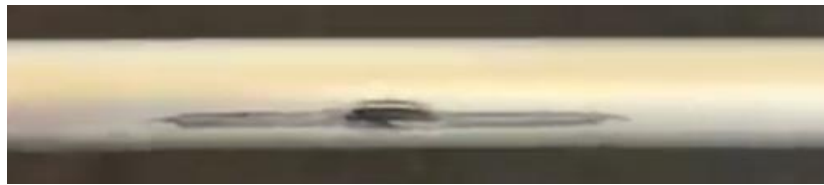
The pushrods will show abrasion on the location of the bearings

high abrasion after app. 5.000h TTAFT, measurement required

Due to the prevailing tolerances of the pushrods (protruded aluminum tubes), measuring the abrasion is a 2-step procedure.

1. Measure the outer diameter of the pushrod outside the bearing area. Nominal diameter is 20mm.
2. Measure area with abrasion. A max. material removal of 0,1mm is acceptable in any location.
