Service Bulletin

Inspection and Replacement of Aluminium Carrythrough of Main Landing Gear (for aircraft equipped with alu/steel landing gear)

Release Number: SB-001-landing-gear

Models affected: G-3, G-3/600, GX

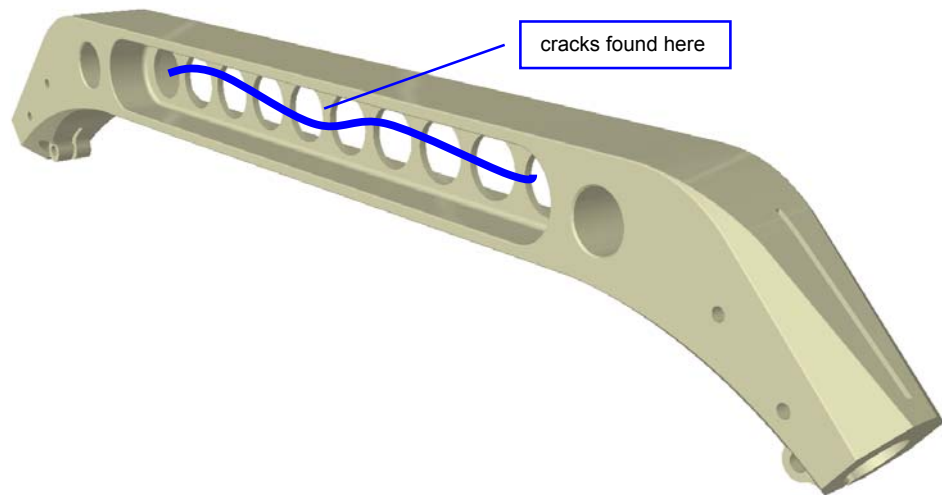
- a. Detach landing gear belly fairings. To do so detach the hex socket screws of the belly fairings and slide them down the landing gear leg fairing.
- b. Inspect the main gear carrythrough for cracks. Especially watch for damages and cracks near the weight reduction holes.

- c. In case that no cracks have been found attach the belly fairings again.
- d. Make a logbook entry of this check.
- e. In case that damages are detected, contact your REMOS Service Center (www.remos.com). The landing gear carrythrough must be replaced. Do not fly the aircraft.
